FACILITY STATUS CHANGE FORM

Date Submitted: January 24, 2013 Originator: Chris Strand Phone: 554-2720	Area: 300 Area Facility ID: 3506A and 3506B Action Memorandum: Action Memorandum #3	Control #: D4-300-078
---	---	---------------------------------

Attachment 1: Facility Information

Attachment 2: Project Photographs

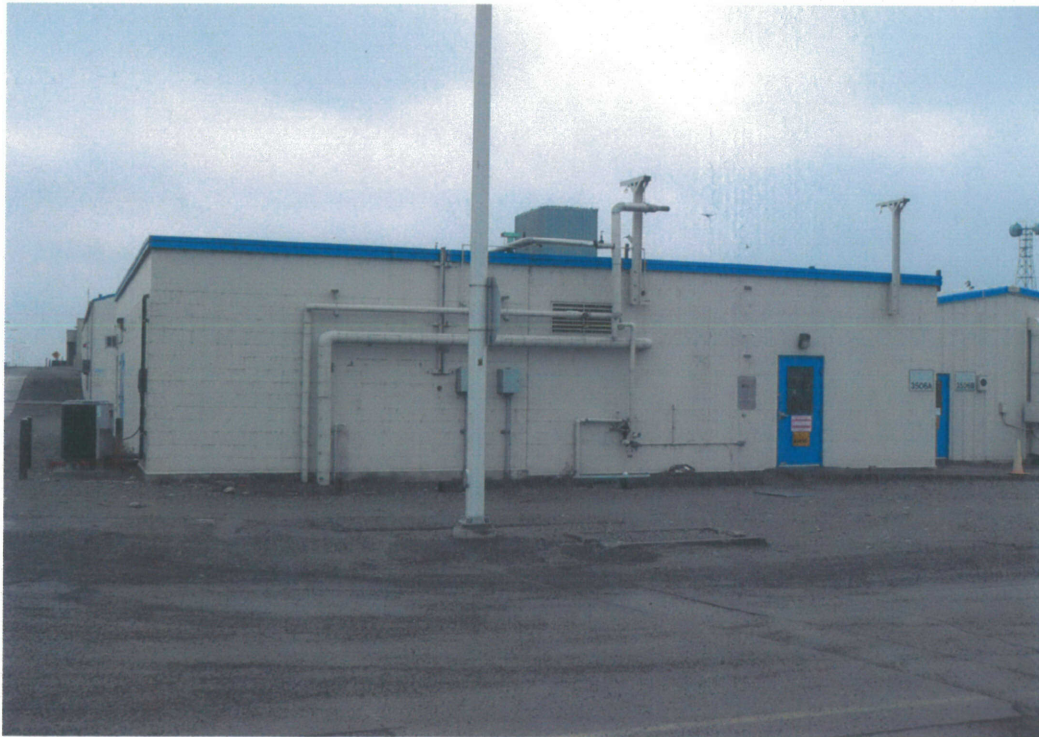
Photograph 1: 3506A looking south, January 26, 2005.

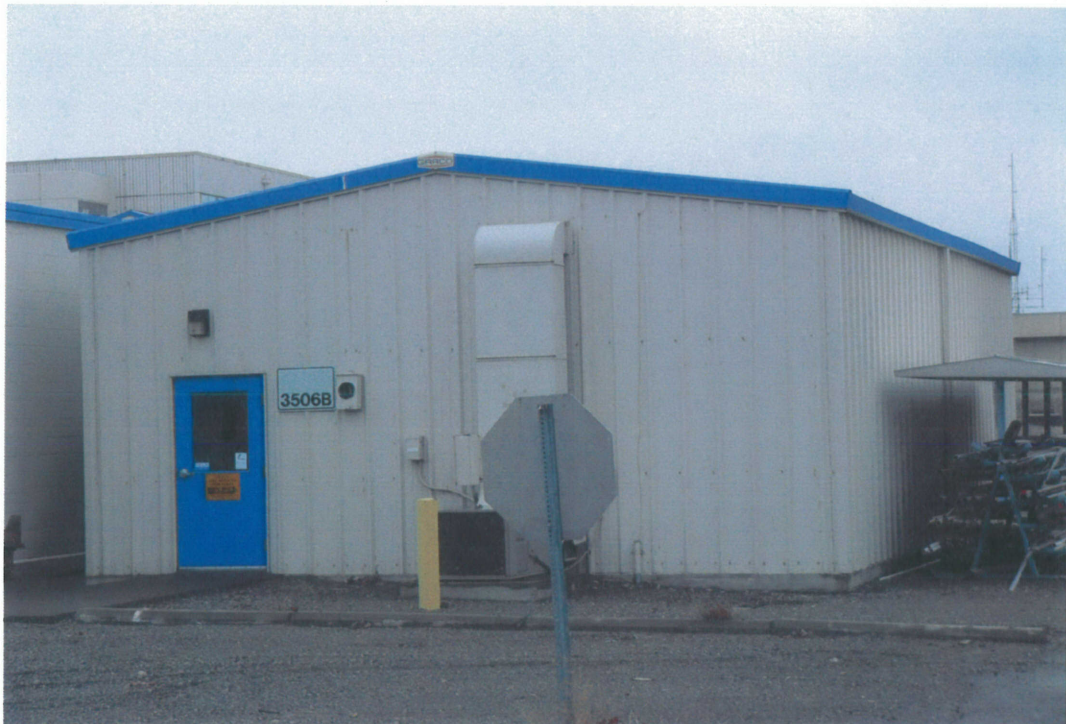
Photograph 2. 3506B looking south on January 26, 2005.

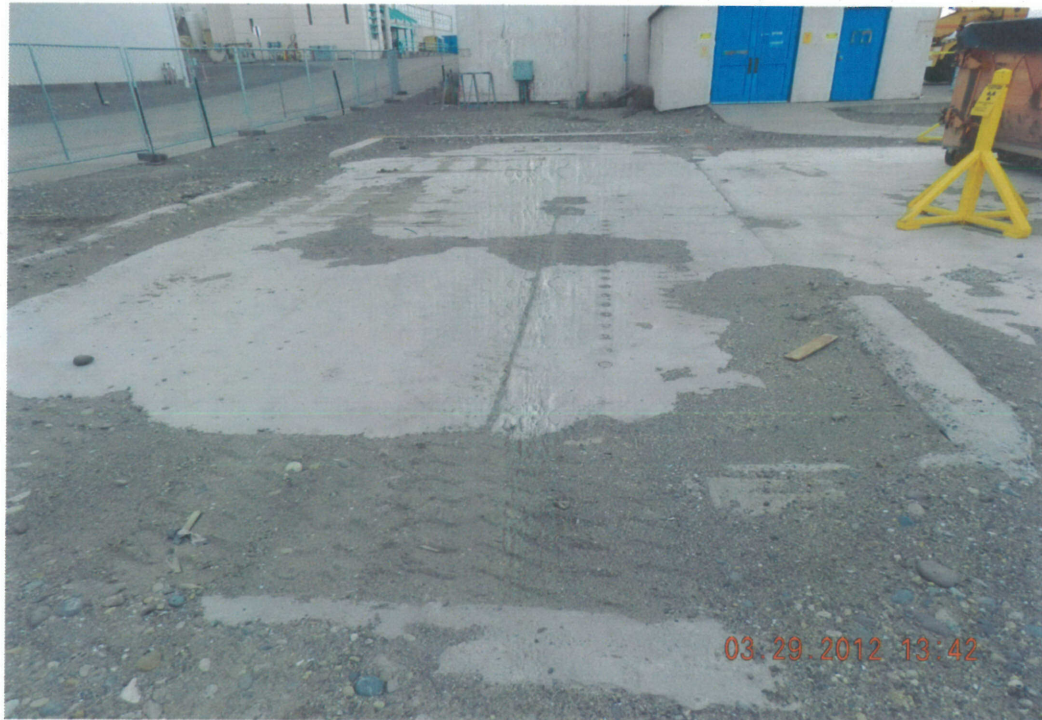
Photograph 3. 3506A slab looking south March 29, 2012.

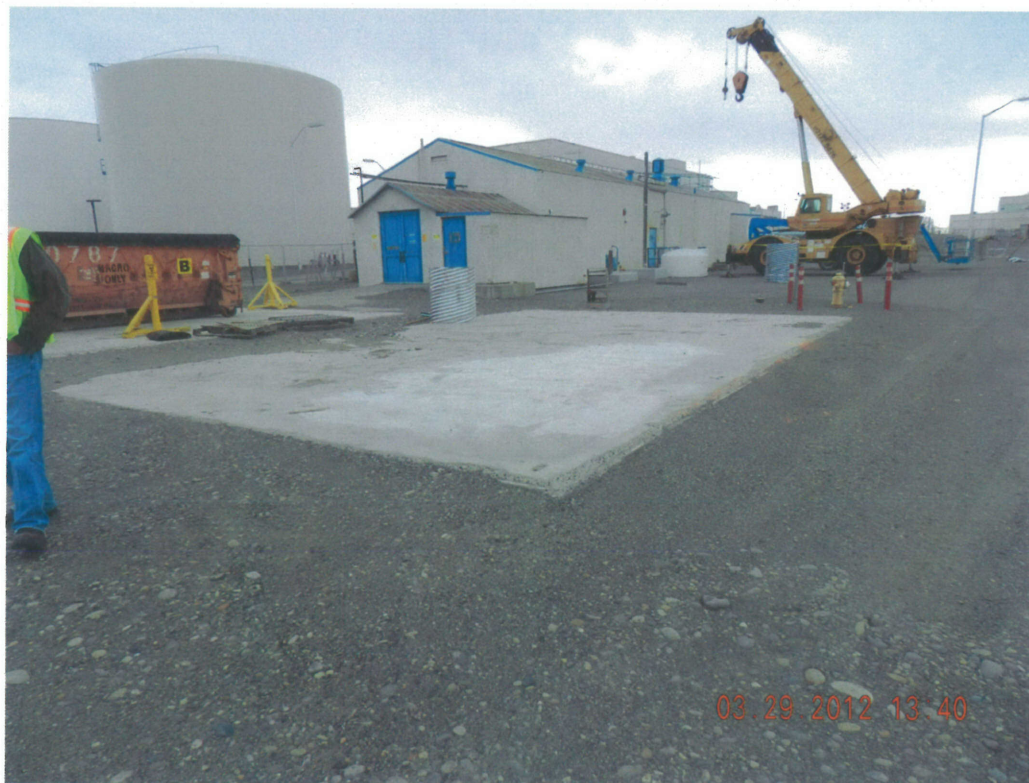
Photograph 4. 3506B slab looking southeast on March 29, 2012.

During removal of the 3506B, asphalt was encountered beneath the slab. It was determined the building was installed over a pre-existing asphalt apron that surrounded 3506A. All asphalt was removed from the excavation prior to backfill.

During removal of 3506B footings, a plastic bag was unearthed and partially torn open. Work was stopped and a closer inspection identified the bag contained PPE (coveralls, respirators, and respirator cartridges) and a white powder substance. Radiological surveys identified no contamination. To facilitate an expedited response, the white powder was declared presumed asbestos containing material (ACM). The area was posted and the debris, including the powder, was hand removed and bagged under ACM controls. Following cleanup, the area was inspected and down-posted by an ACM competent person.

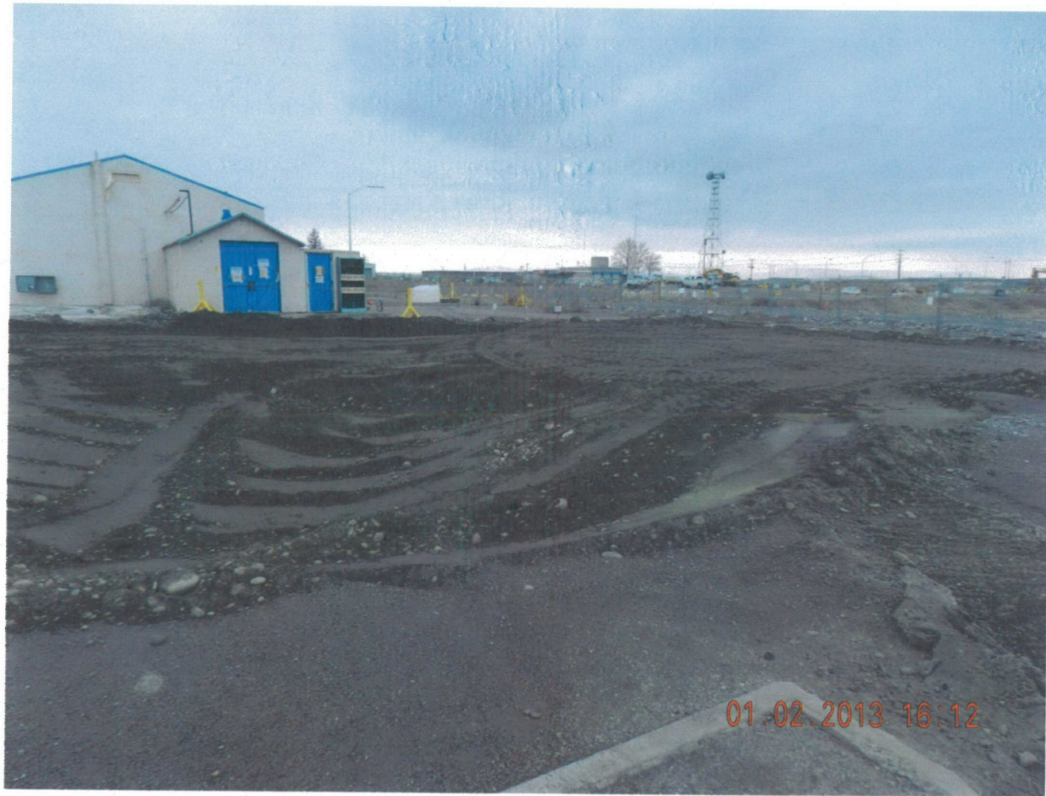
Photograph 5. 3506A and 3506B excavation looking south on January 2, 2013.

Demolition: Below-grade demolition of the 3506A and 3506B slabs were completed in December 2012. The excavation area was backfilled to grade with clean fill. Slab and foundation debris from demolition was removed and disposed of at ERDF. The demolition was performed with Radiological and Industrial Hygiene controls.

A final inspection of the 3506A excavation identified some dark streaking/stained soils along the east side of the layback. A closer inspection confirmed the material was asphalt that was introduced into the layback face from the excavator penetrating the asphalt apron that surrounded the building. All asphalt contamination was hand removed from the excavation prior to backfill as confirmed by a second visual inspection.

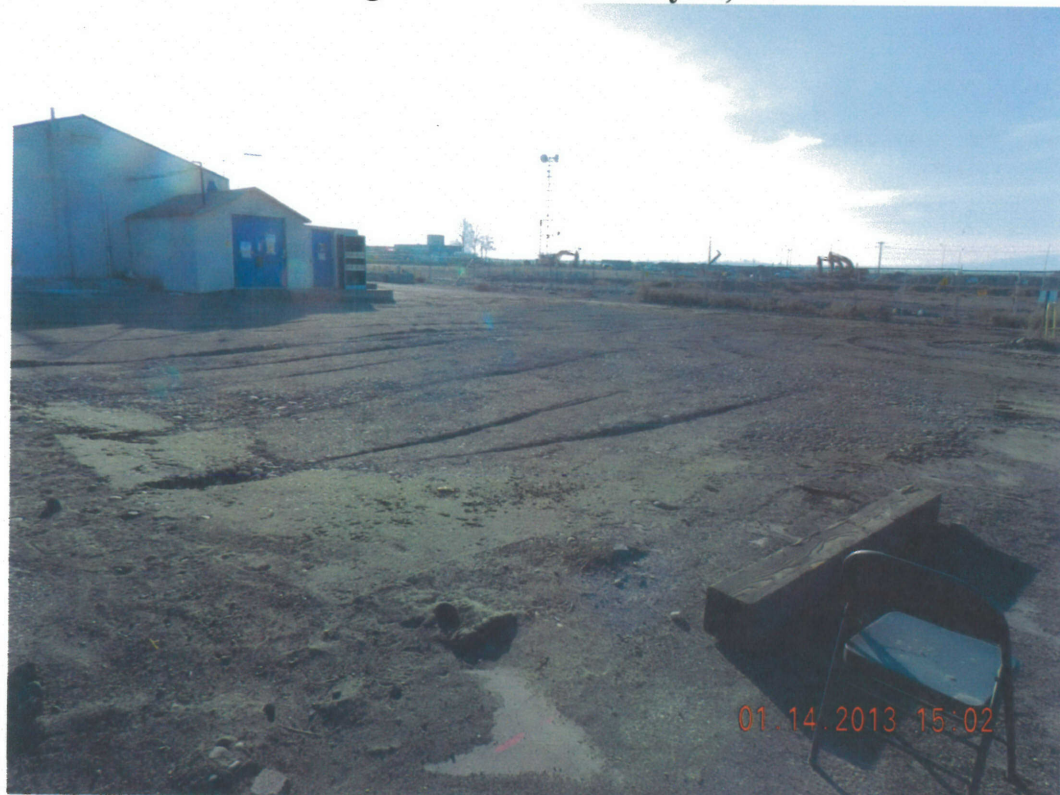
Photograph 6. 3506A and 3506B following backfill, looking southwest on January 14, 2013

All above-grade structures and foundations were removed. Excavations were backfilled to grade with clean fill. GPERS surveys were performed prior to backfill. No radiological or Industrial Hygiene postings remain.
